## North Coast Regional Water Quality Control Board

### Water Quality Inspection Report

**Inspection Date: January 28, 2019**

Main production area and fields at 647 Nissen Road, Ferndale, CA, Eel River Watershed.  
Additional cattle raising area at 3210 Goble Lane, Ferndale, CA, Salt River Watershed.

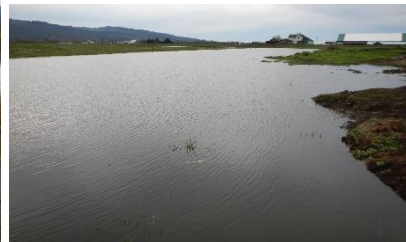
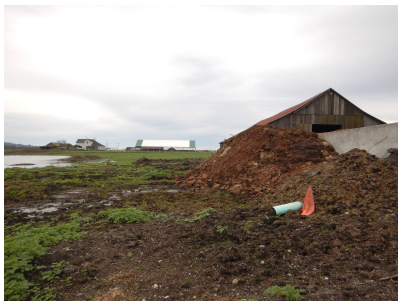
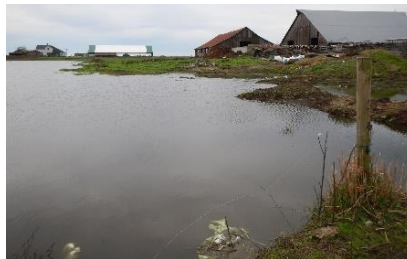
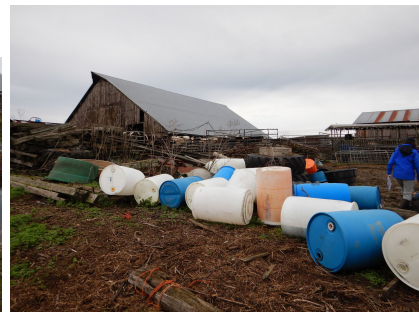
**Area D: Dairy Property At 3210 Goble Lane, Ferndale**

The Avelar property at 3210 Goble Lane was inspected due to the anonymous complaint that manure and blue plastic barrels were stacked along a tributary slough in the Salt River watershed. During the inspection, Regional Water Board staff observed dozens of cows housed at the barn and in the corral. The area is surrounded by dairy pasture. Dirt/manure piles with dead cow carcasses, several empty 55-gallon drums, tires, and other dairy debris were observed within or directly adjacent to the slough in the Salt River watershed. **Recommendation 5:** All manure, dirt, and dairy debris must be moved away from the slough and stabilized where it cannot discharge to waterways.

The current Water Quality Plan does not show the dairy buildings and corrals at 3210 Goble Lane as part of Avelar Dairy. **Recommendation 6:** The full parcels for the dairy barns, corrals, and storage area must be included in the maps for coverage under the dairy permit. Please certify to the Regional Water Board that this area is used for Avelar Dairy by amending the Notice of Intent, signed letter to the Regional Water Board, or by adding it to the next certified report submitted such as the Annual Report (see question regarding changes on page 1).
